## **SURVEY OF THE DAM «GEGHARKUNIK 2»**

The Gegharkunik 2 reservoir is located within the land boundaries of the settlement of the same name, 900 m southeast of the village cemetery, on the elevation of the northeastern slope of the Geghama ridge, at an altitude of about 2220 m. The water in the bowl doesn't stay for long. Studies have shown that most of the water loss happens at the lower part of the dam,

where there are many washouts. This means the reservoir not only fails to serve its main purpose but also poses a significant threat to the Gegharkunik community if the dam were to fail. The paper presents the results of a survey of the «Gegharkunik 2» dam.

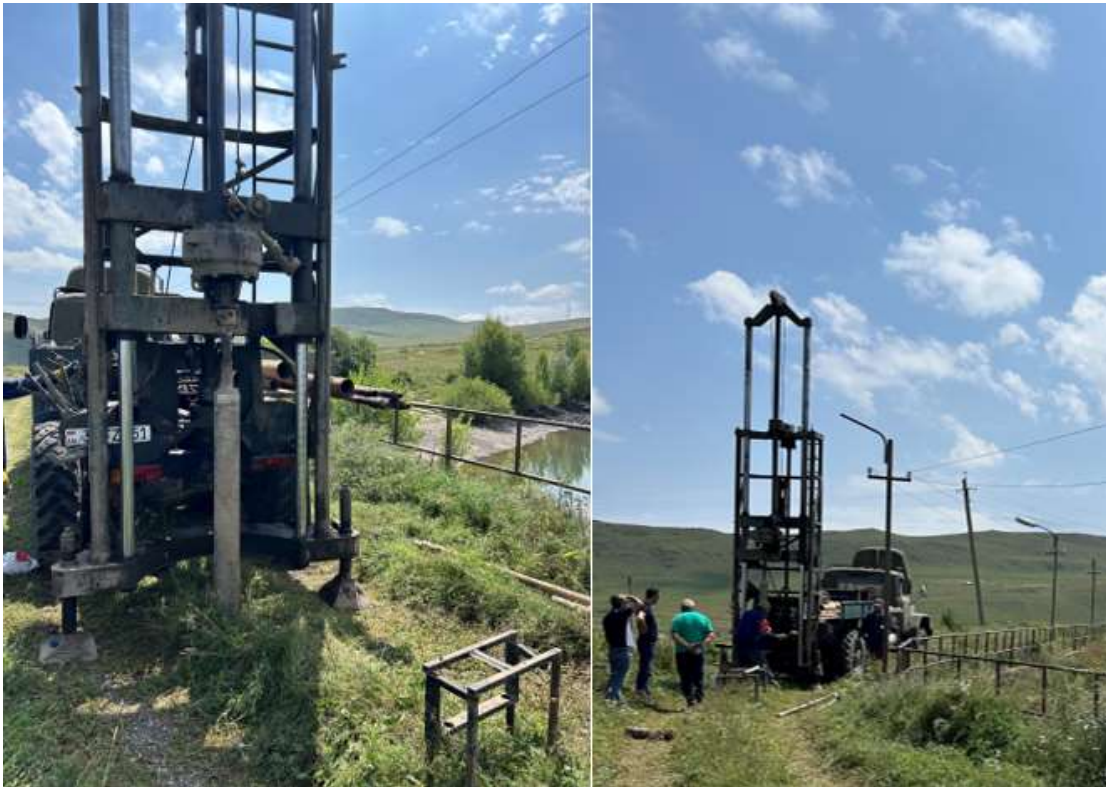
The assessment of the soil condition of the dam body was carried out by drilling two wells to the foundation, under the supervision of geological engineer S. Jeyranyan (Fig. 1).

The boreholes were drilled at the site of the gulch formation that appeared on July 5, 2020, at a distance of 20.0 m from each other, which included the possible range that could theoretically be damaged by the gulch activity.

**Fig. 1 Drilling of two wells in the body of the dam «Gegharkunik 2»**

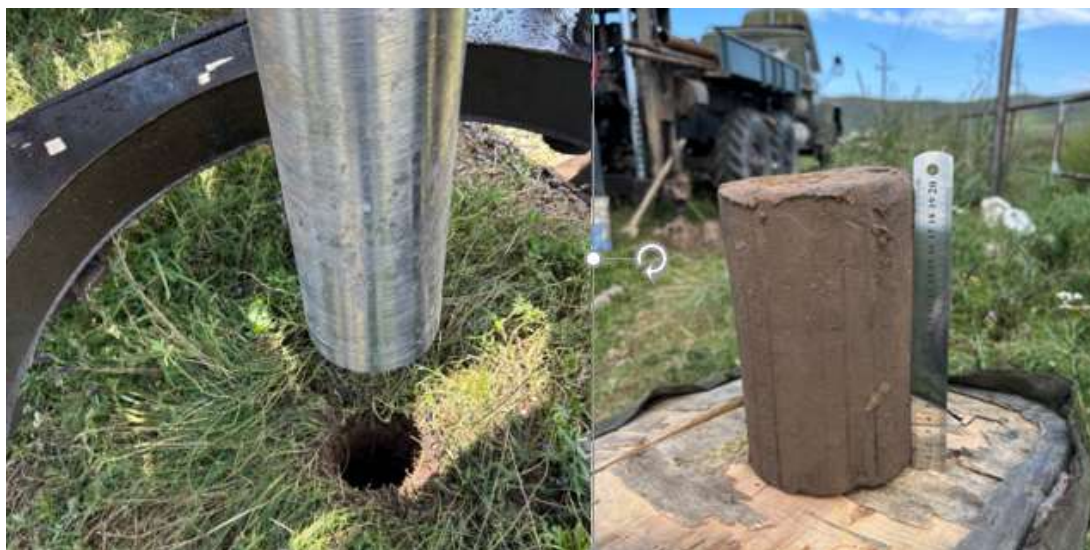
In addition to the in-kind studies of the condition of the dam body soil, five samples of the natural state (monolithic) were selected for laboratory studies in order to assess their physical and mechanical properties (Fig. 2).

**Fig. 2 Samples of natural state (monolithic) soil of the dam body «Gegharkunik 2»**

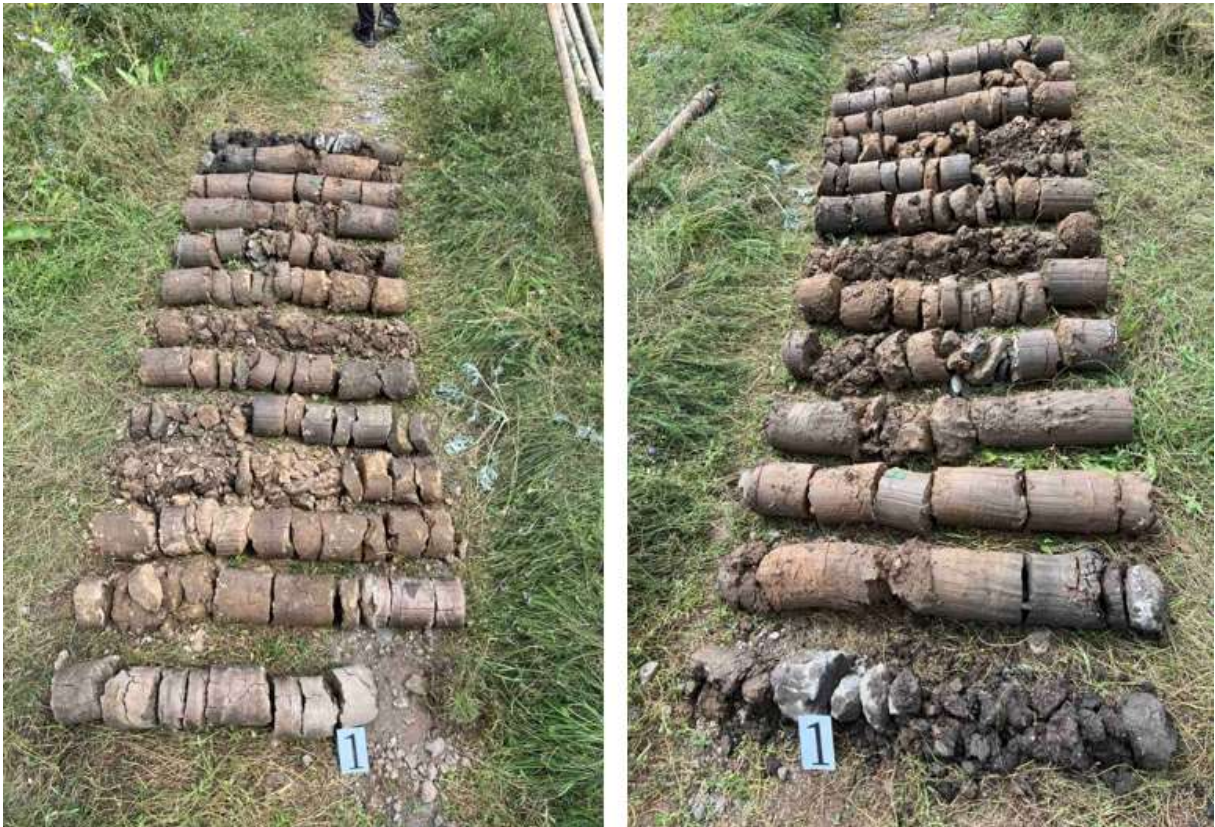
The first well is located at point PK 0+65, calculated from the crest of the catastrophic spillway (Fig. 3).

**Fig. 3 Drilled cores from the first well**  
 (Left - cores at the beginning, Right - cores at the end)

- 0.0-0.2m - Dam embankment is road fill with gravel material of volcanic rocks;
- 0.2-1.3 m - Gray-brown-black-brown loams, heavy sandy loams with a content of detrital material of more than 10%;
- 1.3-11.8 m - Dam body. Successive layers of brown-chestnut-black-brown strong sandy loams of varying degrees of compaction;
- 11.8-13.0 m - Pebble deposits of volcanic rocks (basalts, andesites) with chernozem.

The well is dry.

4. The cores taken from the dug boreholes show that the contact part of the dam body and the relief contains remains of black soil and gravel material of basalt composition, which indicates that at the initial stage of the dam construction the foundation was not completely cleared to the surface of the basalt layer. In these conditions, it is encouraging that to date there have been no active outflows of filtered water from the foundation of the dam.

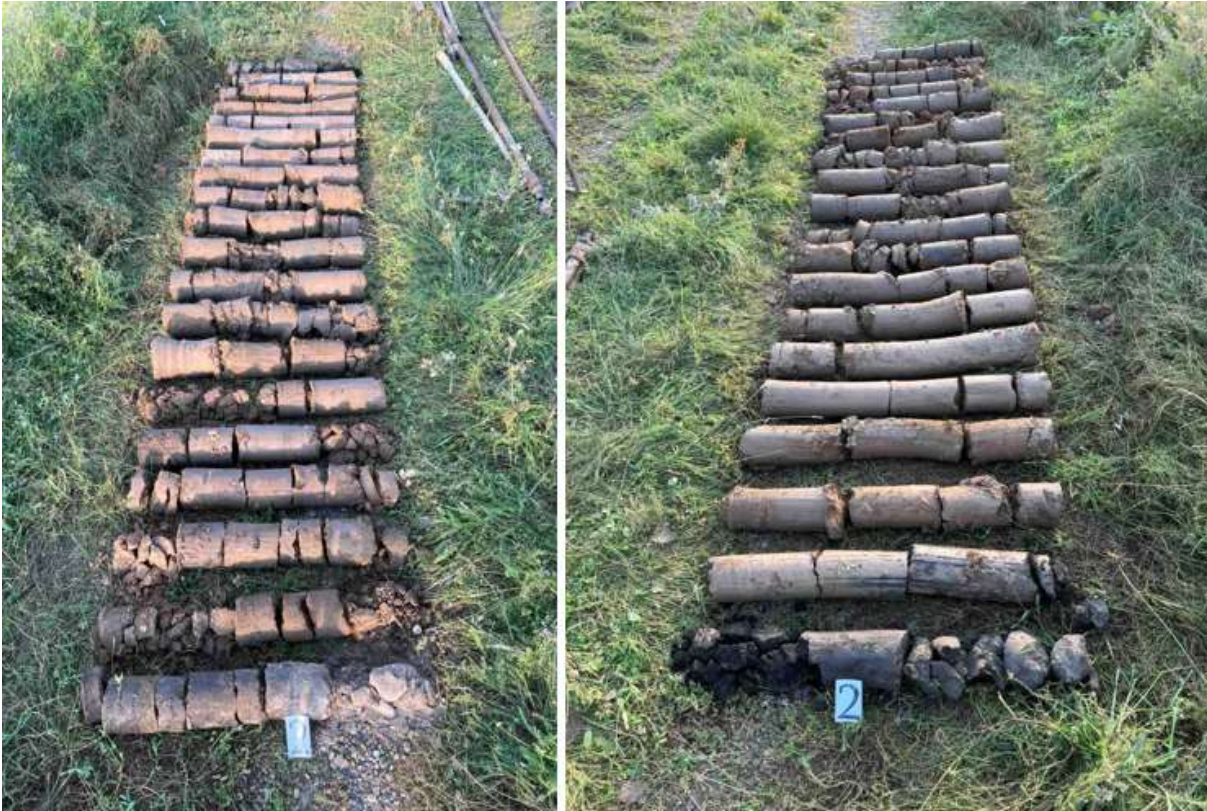
The second well is located at point PK 0+85, calculated from the crest of the catastrophic spillway (Fig. 4).

- 0.0-0.3m - Dam embankment is road fill with gravel material of volcanic rocks;
- 0.3-1.0m - Gray-brown-black-brown, heavy sandy loam with a detrital material content of about 10%;
- 1.0-18.5 m - Light brown to brown loams, moderately moist, slightly charred, hard sandy loams, almost without debris;
- 18.5-19.5 m - Black soil of sandy-clay composition with almost no crushed stone mixture;
- 19.5-20.0 m - pebble deposits of the weathered upper layer of bedrock basaltic andesites.

The well is dry.

**Fig. 4 Drilled cores from the second well**  
(Left - cores at the beginning, Right - cores at the end)

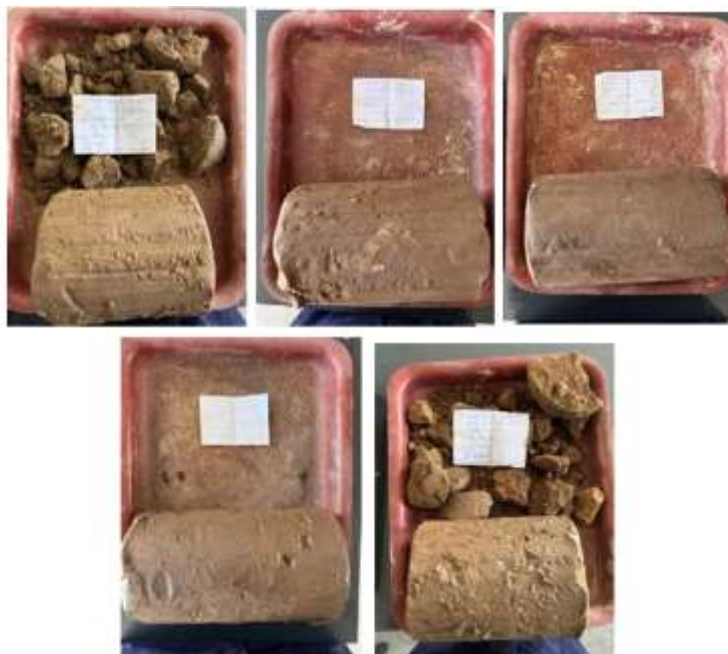
Tests of the taken soil samples were carried out in the geomechanics laboratory of the Institute of Mining and Metallurgy of Armenia. Random testing was carried out in accordance with international standards (Fig. 5). It was decided:

**Fig. 5 Random testing of selected soil samples**

As a result of the work performed, it was established that the material of the dam body is represented by moderate moisture, from light brown to brownish in color, slightly charred, hard sandy loams, almost without admixture of crushed stone. They are characterized by the following physical indicators:

- specific gravity 2.69-2.71 g/cm<sup>3</sup>;
- density 1.66-1.69 g/cm<sup>3</sup>;
- porosity 48.96-49.87%;
- humidity level 0.587-0.654;
- plasticity limit 26.08-30.07;
- plasticity index 0.06-0.60;
- friction angle 16.27-28.17°;
- filtration coefficient 0.05-0.08 m/day;
- deformation modulus 115-134 kg/cm<sup>2</sup>;
- initial design resistance 1.8 kg/cm<sup>2</sup>;
- compatibility coefficient 3000 t/m<sup>3</sup>;
- Poisson's ratio 0.36;
- sliding modulus 78.2-97.1 t/m<sup>2</sup>.

Analysis of the laboratory test results allows us to conclude that the obtained physical and mechanical parameters almost completely correspond to the requirements imposed on the dam body material. The somewhat low bulk density of the skeleton of such sandy loams is alarming, which may be a consequence of incomplete compaction of the soil during construction.

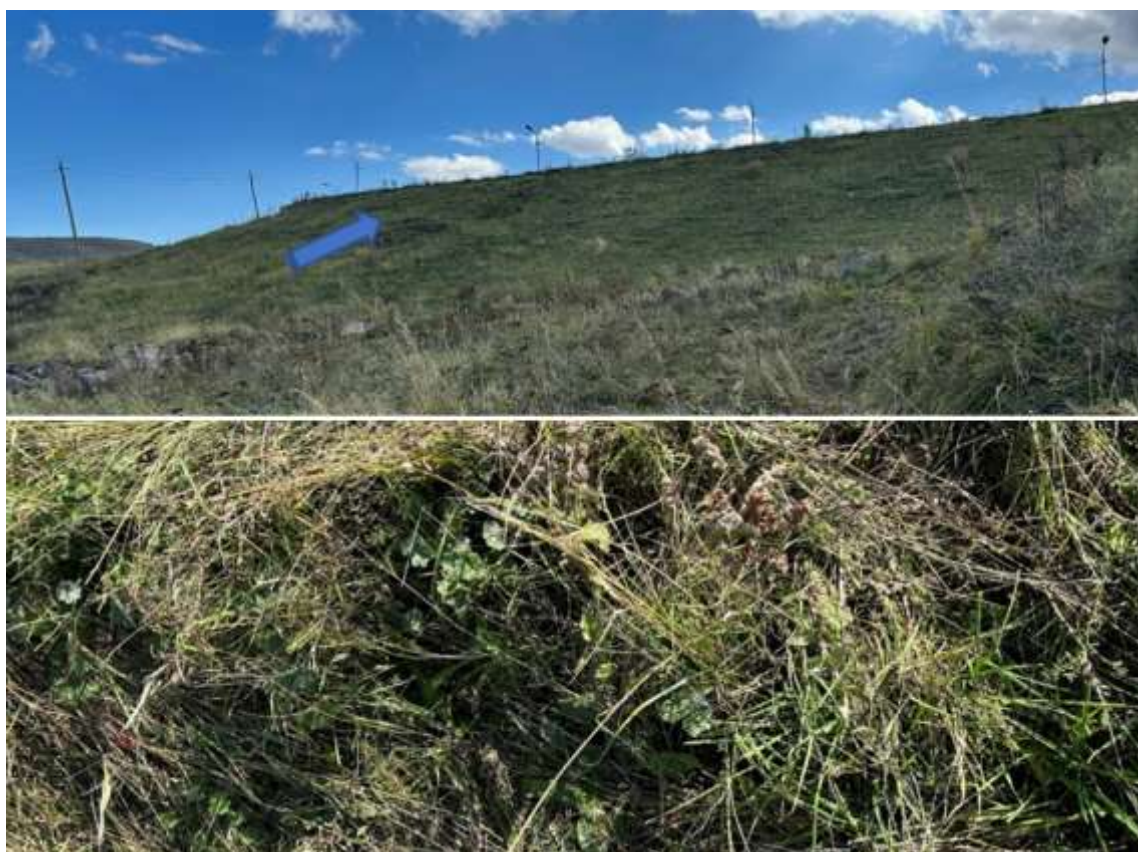
**Fig. 6 Landslides in the lower slope of the Gegharkunik 2 reservoir dam after the appearance of a ravine in 2020**

It should be noted that in places where suffusion soil is removed by the filtration flow from the dam body or foundation below (downstream) the discharge zone, as a rule, there are noticeable deposits of fine soil in the form of tongues, plumes or individual strips.

Visual observations in the lower pool of the «Gegharkunik 2» reservoir show that landslides occurred after the 2020 erosion (Fig. 6).

5. The organization operating the reservoir is recommended to monitor the junction of the dam in order to record observed deviations and take necessary measures.

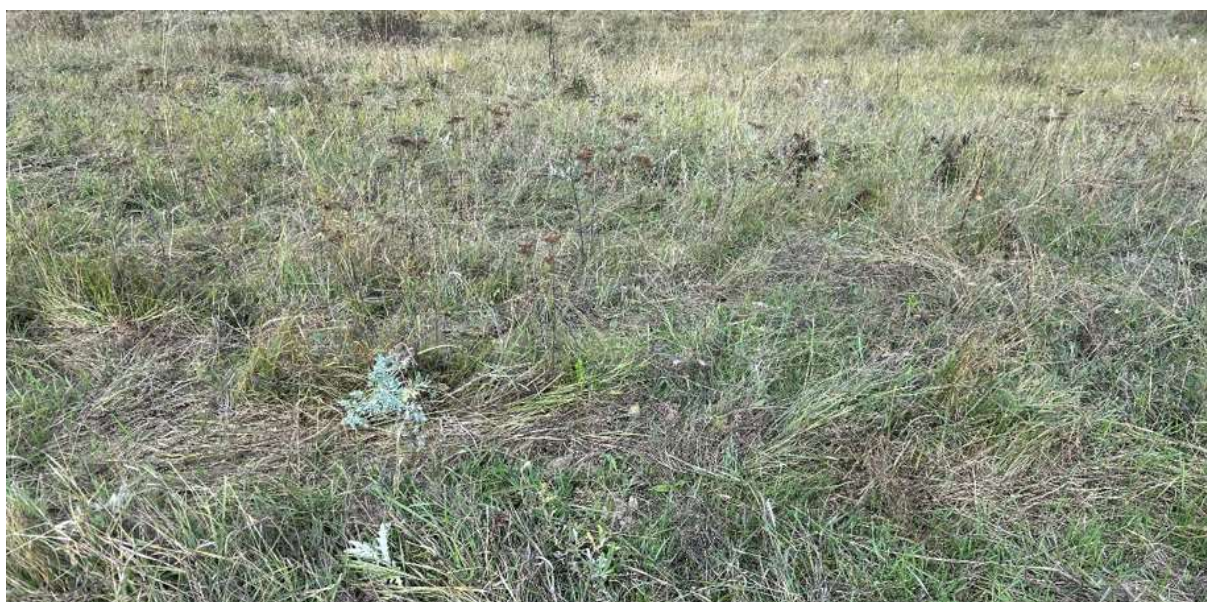
However, the process subsequently stabilized. Currently, there are no differences in the condition of individual vegetation areas in the lower pool (Fig. 7).

**Fig. 7 In the lower pool of Gegharkunik reservoir No. 2 the condition has stabilized (no differences in the condition of individual areas of vegetation are observed)**

3. The slightly lower bulk density of the barrier material skeleton indicates that the barrier material was not fully compressed during construction. The green vegetated area in the lower slope is also a result of incomplete and uneven compaction of the dam material, which is especially noticeable during high water levels in the reservoir.
